Ersun (Westhide SPV) Ltd

Solar Farm at Westhide, Hereford

Construction Traffic Management Plan

November 2021

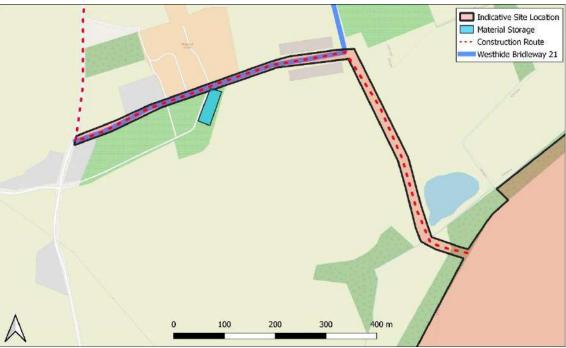
Figure 3.1: Main Construction Access and Layout

3.15 Part of the access route from the C1130 is also a bridleway, 'Withington Bridleway 21'. Given the temporary nature of the construction period and that this route is already used by large agricultural machinery and the excellent safety record of the local highway network, it is considered that this route is suitable for construction traffic associated with the proposed solar farm. The location of the proposed construction access, storage area, internal route and route of the bridleway is demonstrated in **Figure 3.1**.

- 3.16 To protect the existing Bridleway, signage and fencing, as well as a signposted speed limit for drivers, will be erected to ensure users of the Bridleway are aware of the movement of large vehicles in the area; it is noted that agricultural vehicles currently utilise the Bridleway to access the farmland, and therefore those travelling on the Bridleway will likely already take care when doing so.
- 3.17 Furthermore, appropriately trained banksmen will assist in guiding vehicles from the highway to the construction compound, further increasing safety for those travelling on the Bridleway.

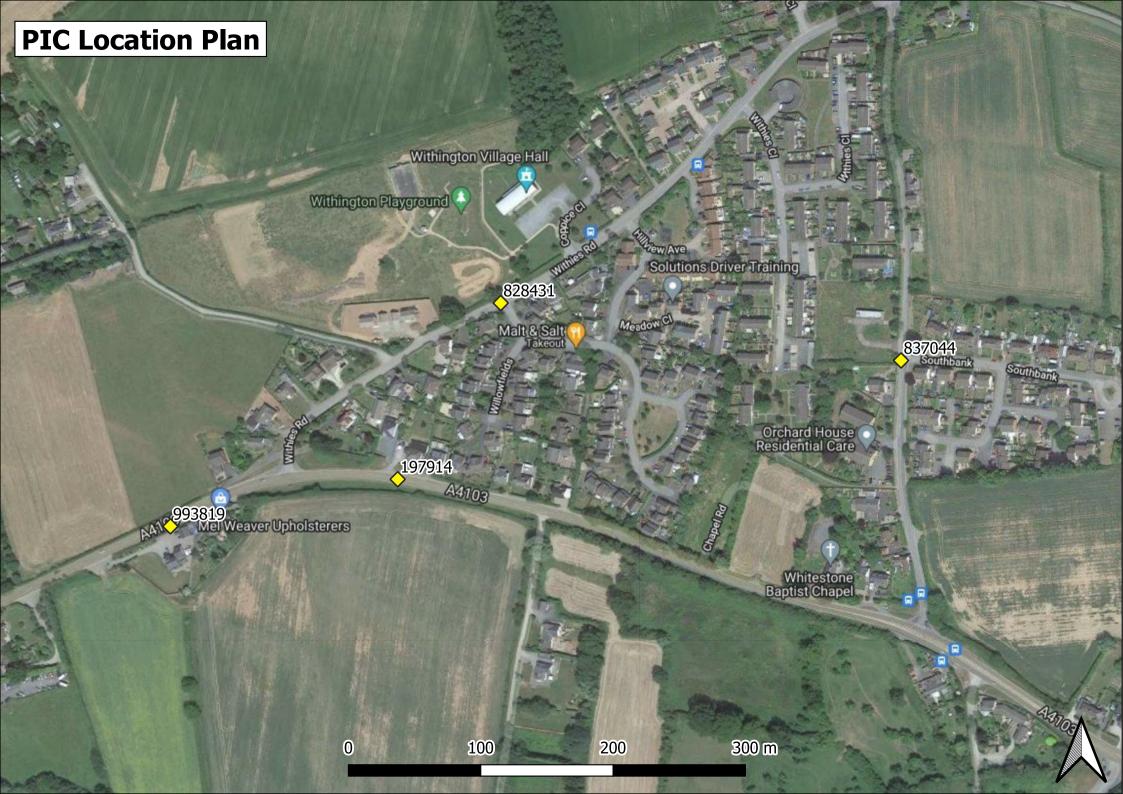
PIC Data

- 2.6 Personal Injury Collision (PIC) data has been obtained from HC for the most recent five year period available, until 24th June 2021, within Withington, off the A4103, as well as the C1130, C1131 and A465 (in the vicinity of the junction with the C1130). This area has been assessed as it will be utilised by vehicles routing towards the application site for construction and servicing purposes.
- 2.7 The review indicated that a total of four PICs had occurred within the study area, during the assessment period, in and around the built up area of Withington, all of which were recorded as 'slight' in severity. Appendix B contains the full PIC report and a plan demonstrating the locations of each incident.

- 2.9 The first PIC occurred on Tuesday 30th May 2017 at 10:50 on a dry road surface. The incident was located on the A4103, approximately 75m east of the junction with Withies Road. A car travelling westbound on the A4103 swerved into the southern verge, before overcorrecting and colliding with a second vehicle travelling eastbound. The first car then corrected themselves and collided with the rear of a third car in the westbound lane. The drivers of the first two vehicles were treated for slight injuries, the causation was attributed to illness or disability in the first driver.

- 2.10 The second PIC occurred on Monday 4th February 2019 at 16:19 on a wet / damp road surface. The incident was located on Withies Road, approximately 125m north-east of the junction with the A4103. A delivery vehicle, parked on the side of the road, pulled out onto the road whilst failing to spot a cyclist, causing a collision between the two. The cyclist was treated for slight injuries, the causation was attributed to a blind spot on the delivery vehicle.

- 2.11 The third PIC occurred on Tuesday 30th April 2019 at 15:38 on a dry road surface. The incident was located at the Southbank priority junction. A car was travelling northbound on an unnamed road, when a child ran into the road from Southbank. The child was struck by the car and was treated for slight injuries, the causation was attributed to the fact the child did not look properly before entering the road, combined with the presence of parked vehicles obscuring their view.

- 2.12 The final PIC occurred on Thursday 8th October 2020 at 08:58 on a dry road surface. The incident was located on the A4103, approximately 95m south-west of the A4103 / Withies Road junction. A car was travelling westbound into Hereford, when they lost control of the vehicle and collided with a car travelling in the opposite direction. Both drivers were treated for slight injuries, the offending driver tested positive for alcohol and / or drugs.

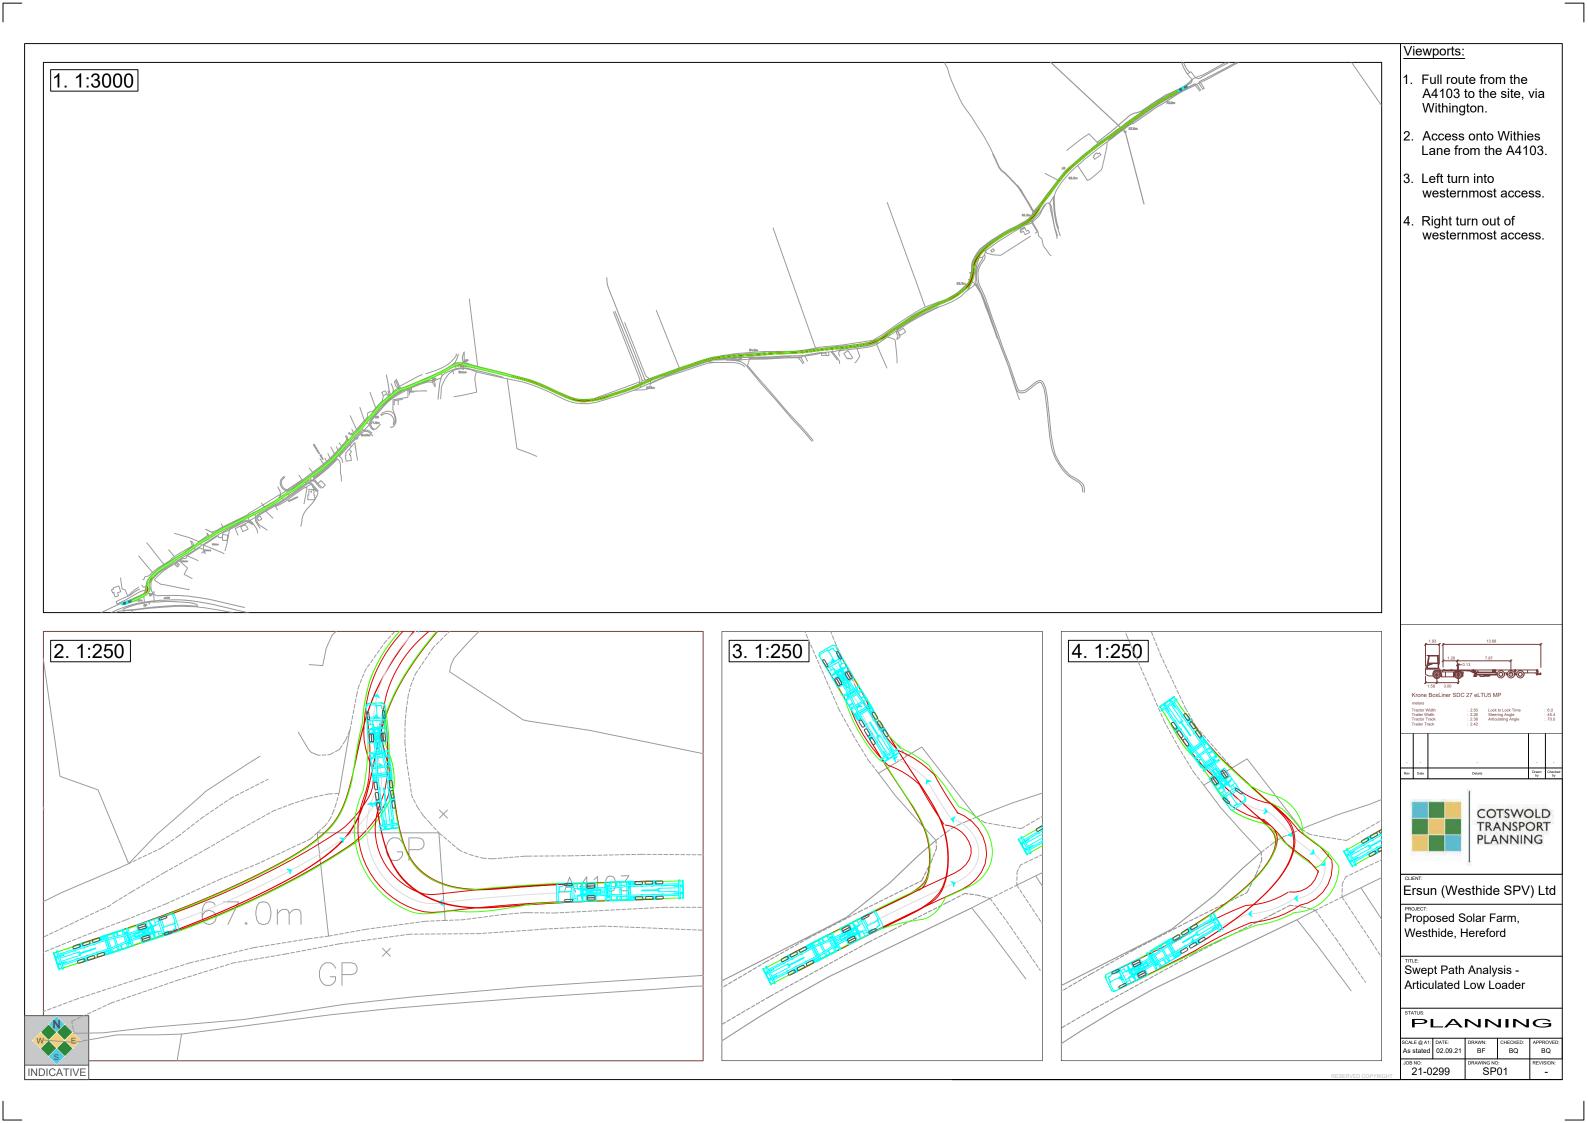
Transformer Routing Plans

- 3.3 The transformer will be delivered on an articulated low loader and due to the swept path of this vehicle, it cannot be transported along the main construction access track by a smaller vehicle. As such, the transformer will be delivered via the C1131, to the south of the site. Whilst the majority of construction vehicles will travel to / from site via the main construction access route to the north of the site, it is envisaged that some construction vehicles will need to access the site from the south, alongside the transformer delivery.

- 3.4 A routing plan and swept path analysis drawing have been produced and provided at **Appendix E**, which demonstrates an articulated low loader vehicle accessing and egressing the site in a forward gear, from the A4103 to the south of the application site and along the C1131.

- 3.9 The swept path analysis indicates that a vehicle may require use of the adjacent verge to perform manoeuvres; to account for this, a condition survey is offered and further discussed in **Section 6**. Note, access to the site from the C1131 by a low loader will only involve two vehicle trips, to / from the site, during the construction period.

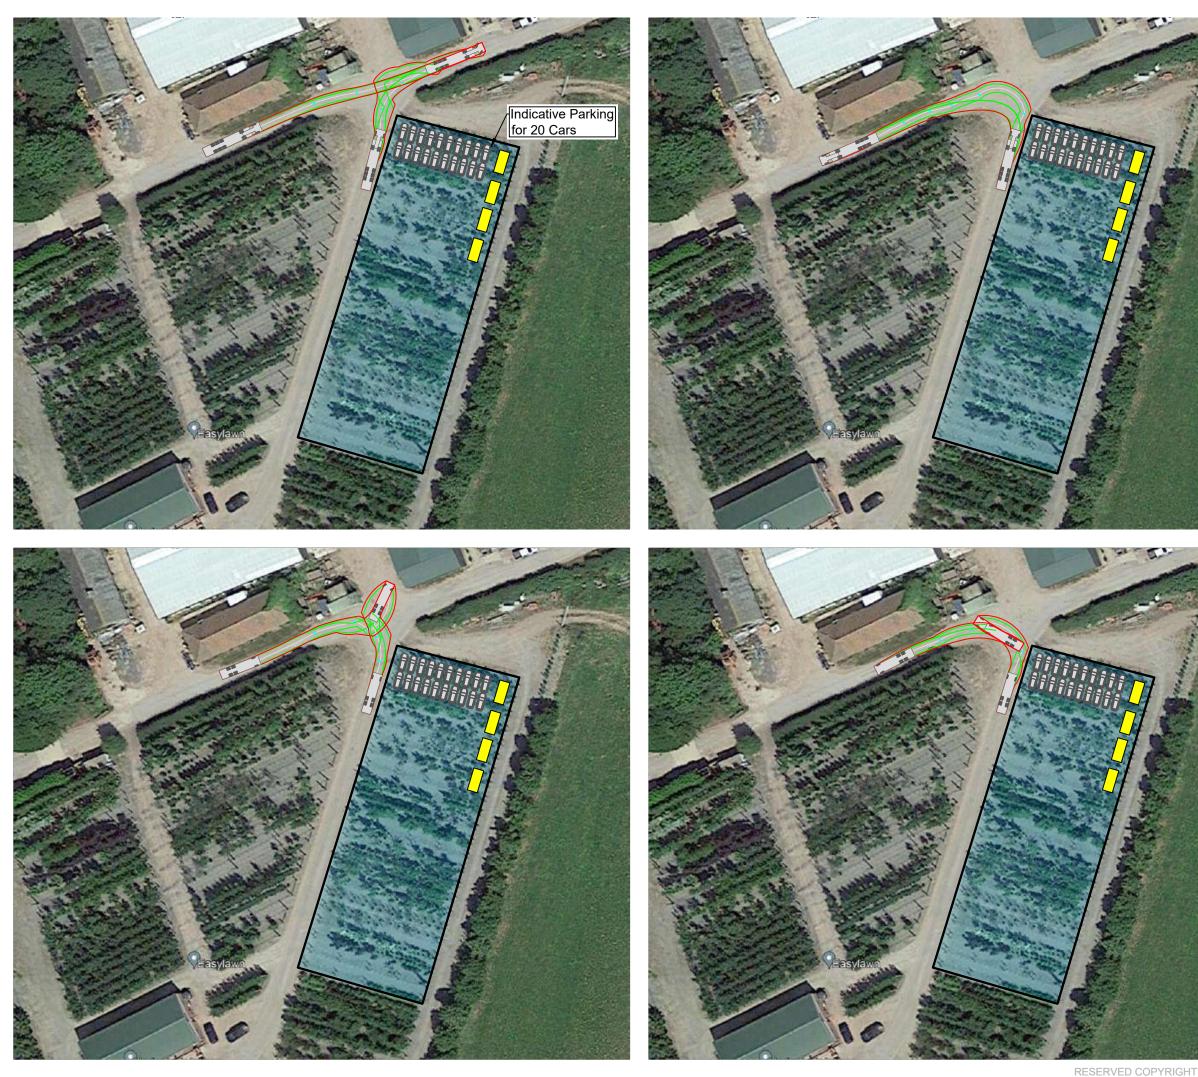
Indicative Construction Compound Layout

- 4.3 **Appendix I** contains an indicative plan demonstrating a potential arrangement of the compound. Included on the drawing are indicative parking areas, welfare facilities and remaining area for plant and material storage. Also contained within the drawings are indicative vehicle swept paths for a 16.5m articulated lorry and 11m rigid truck, demonstrating that they are able to access and egress the area in a forward gear, utilising the land to perform a turning manoeuvre.

- 4.1 A construction compound has been identified within the farm land to the north of the application site as part of the agreement with the land owner. This compound will provide space for facilities, storage and parking.
