Ersun (Westhide SPV) Ltd

Solar Farm at Westhide, Hereford

Construction Traffic Management Plan

May 2022

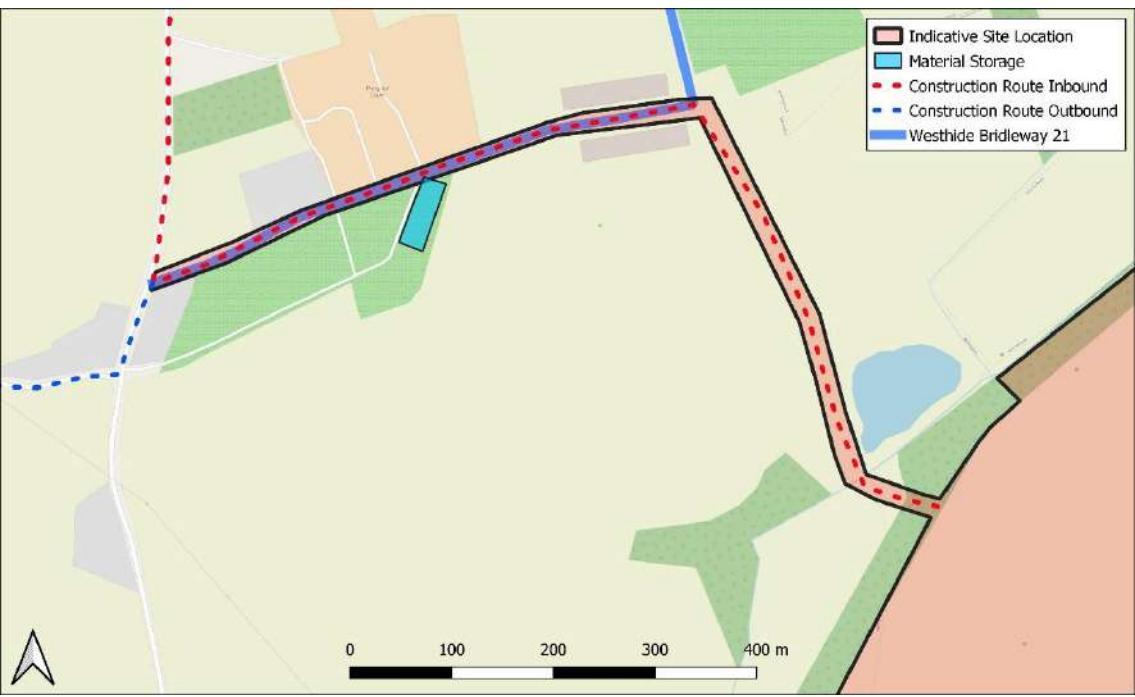
Figure 3.1: Main Construction Access and Layout

- 3.18 Part of the access route from the C1130 is also a bridleway, 'Withington Bridleway 21'. Given the temporary nature of the construction period and that this route is already used by large agricultural machinery and the excellent safety record of the local highway network, it is considered that this route is suitable for construction traffic associated with the proposed solar farm. The location of the proposed construction access, storage area, internal route and route of the bridleway is demonstrated in **Figure 3.1**.

- 3.15 As identified previously, the main construction access will be to the north of the application site from the C1130, via an existing access to a farmstead. Vehicles will access this area via the A465 and the C1130, egressing via Thinghill Lane onto the A465, forming a one-way routing arrangement.

- 3.16 Materials will be held in a storage area / compound within the main farmstead, with smaller vehicles then shuttling to the application site to the south in a 'just-in-time' fashion.

- 3.17 The internal route from the main farmstead area to the application site to the south (approximately 500m) will utilise existing farm vehicle routes across fields that will be reinforced to a suitable standard, likely with a crushed aggregate.

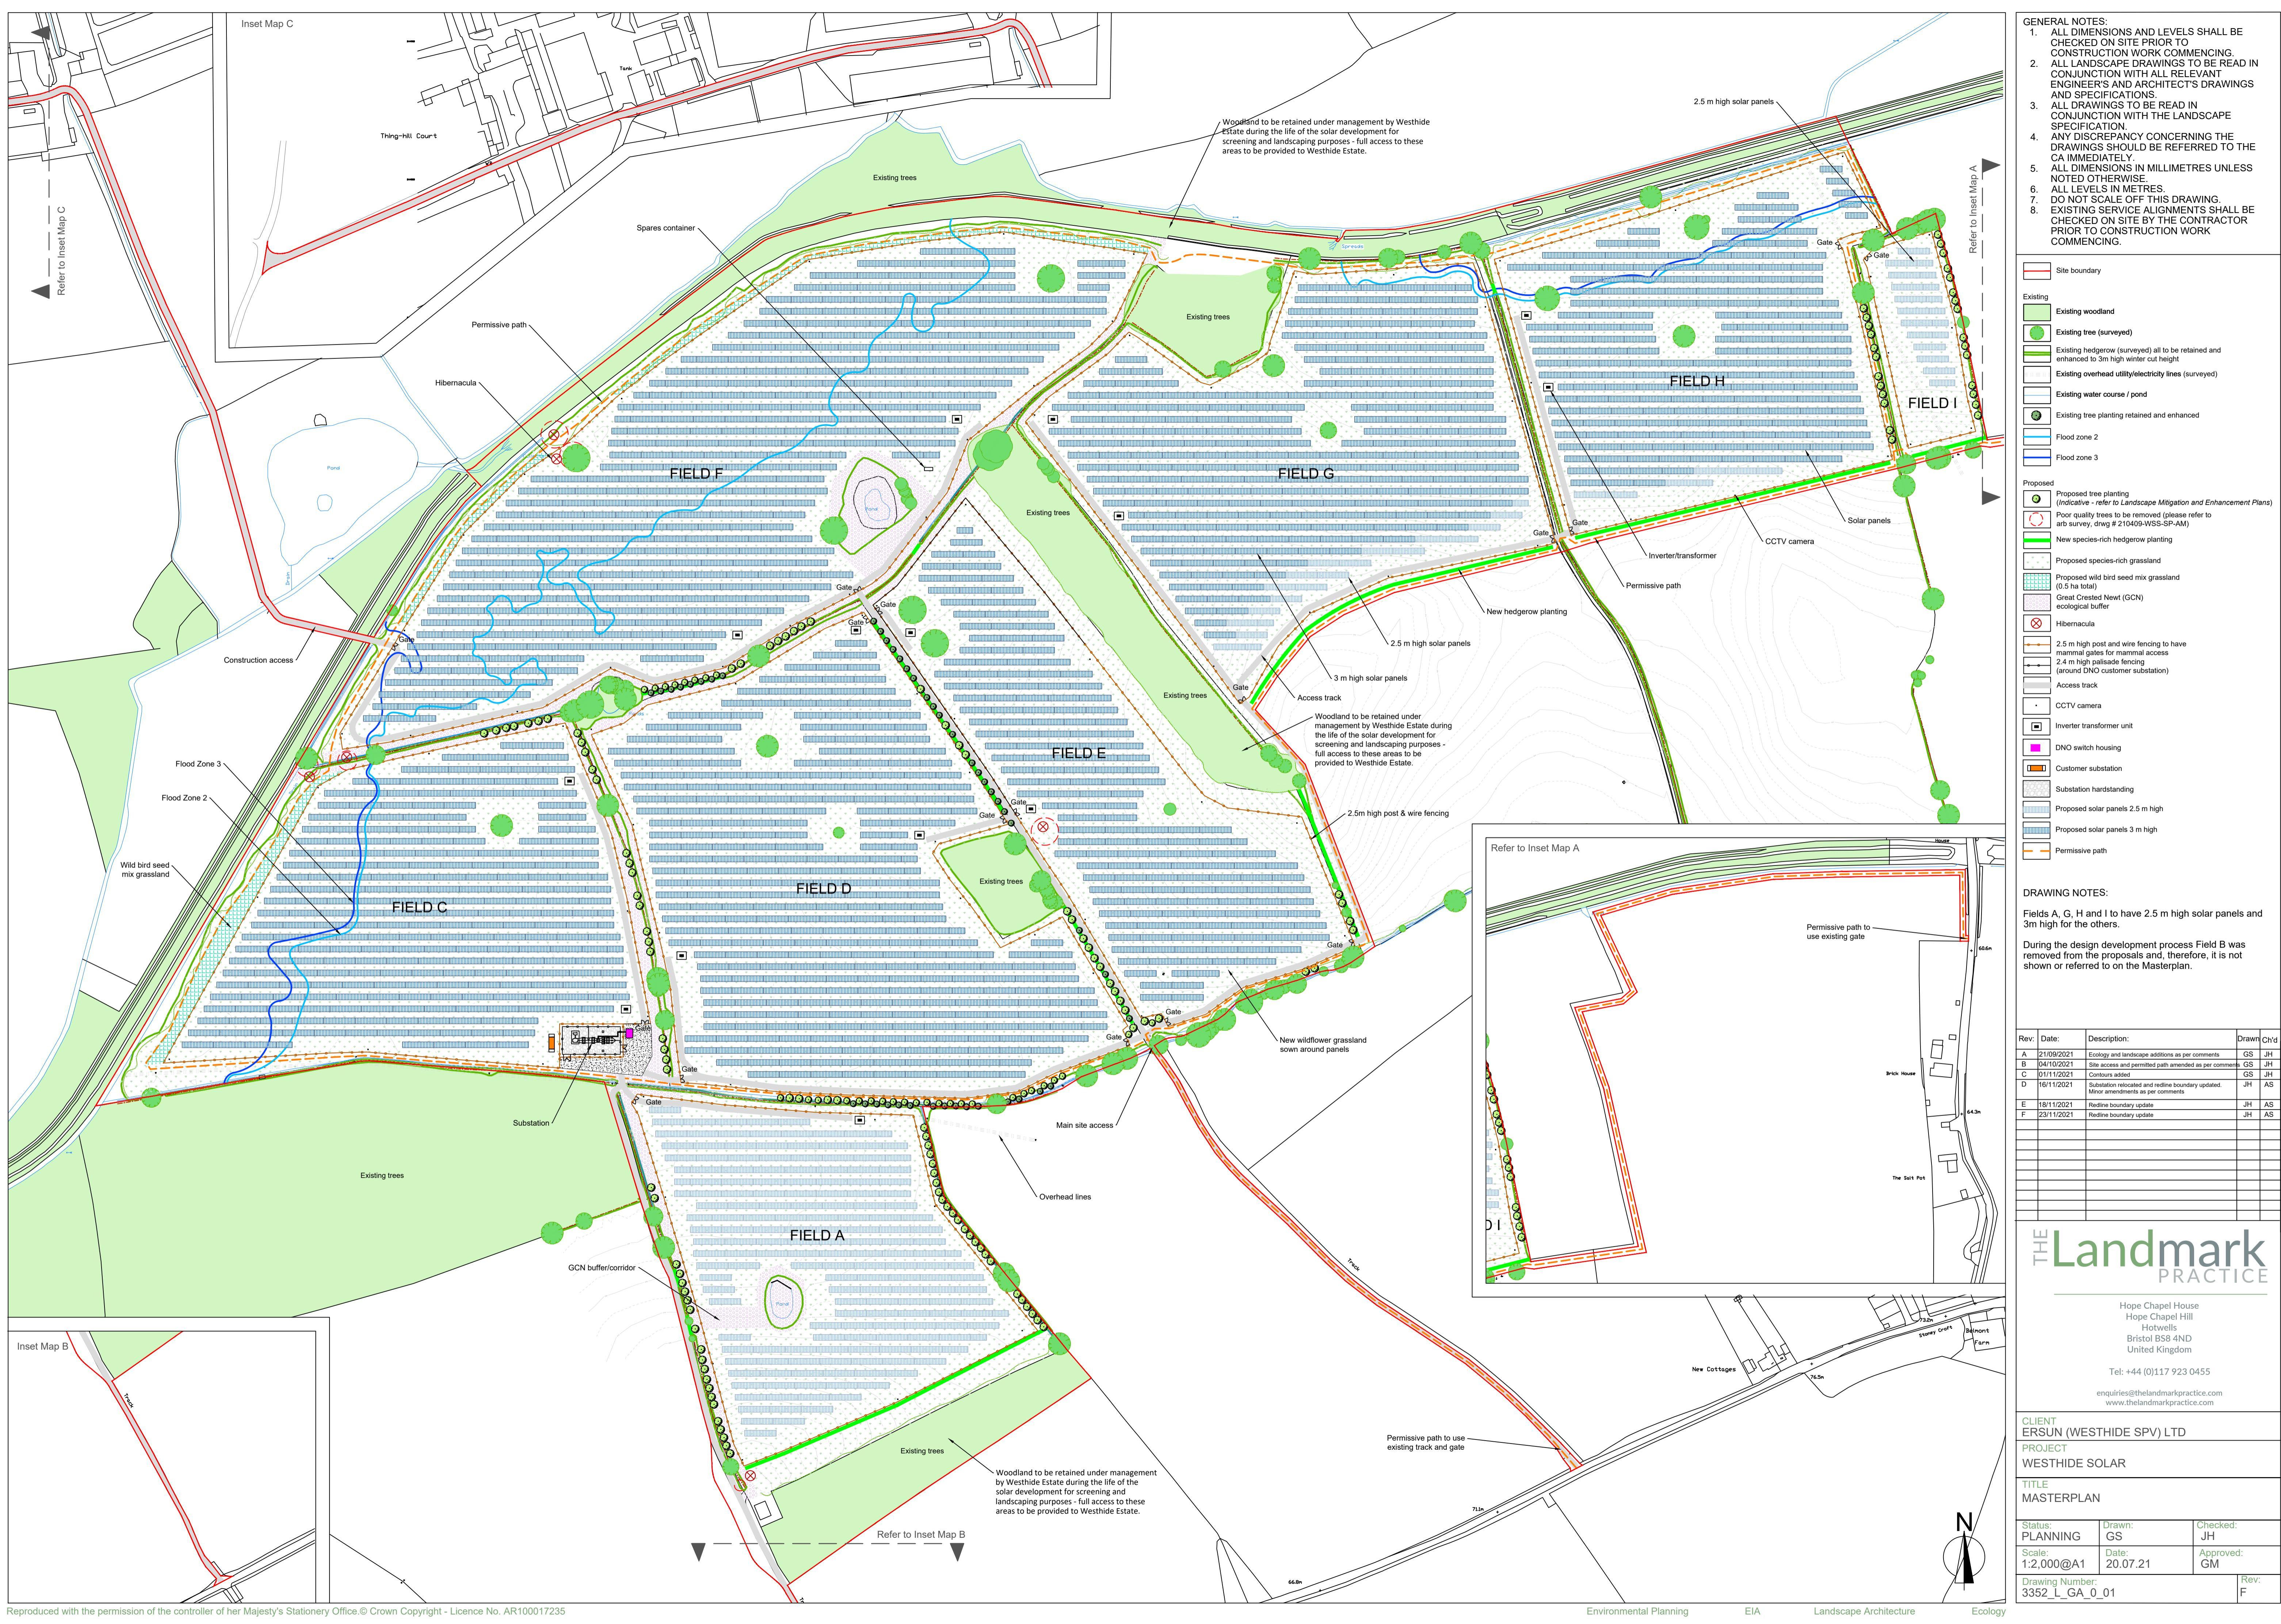
Site Layout Plan

2.1 The application site is located on land to the north of the C1131, which connects Withington and Westhide in Herefordshire. The site is bound in all directions by undeveloped land. The site location is demonstrated on the layout plan provided at **Appendix B**.

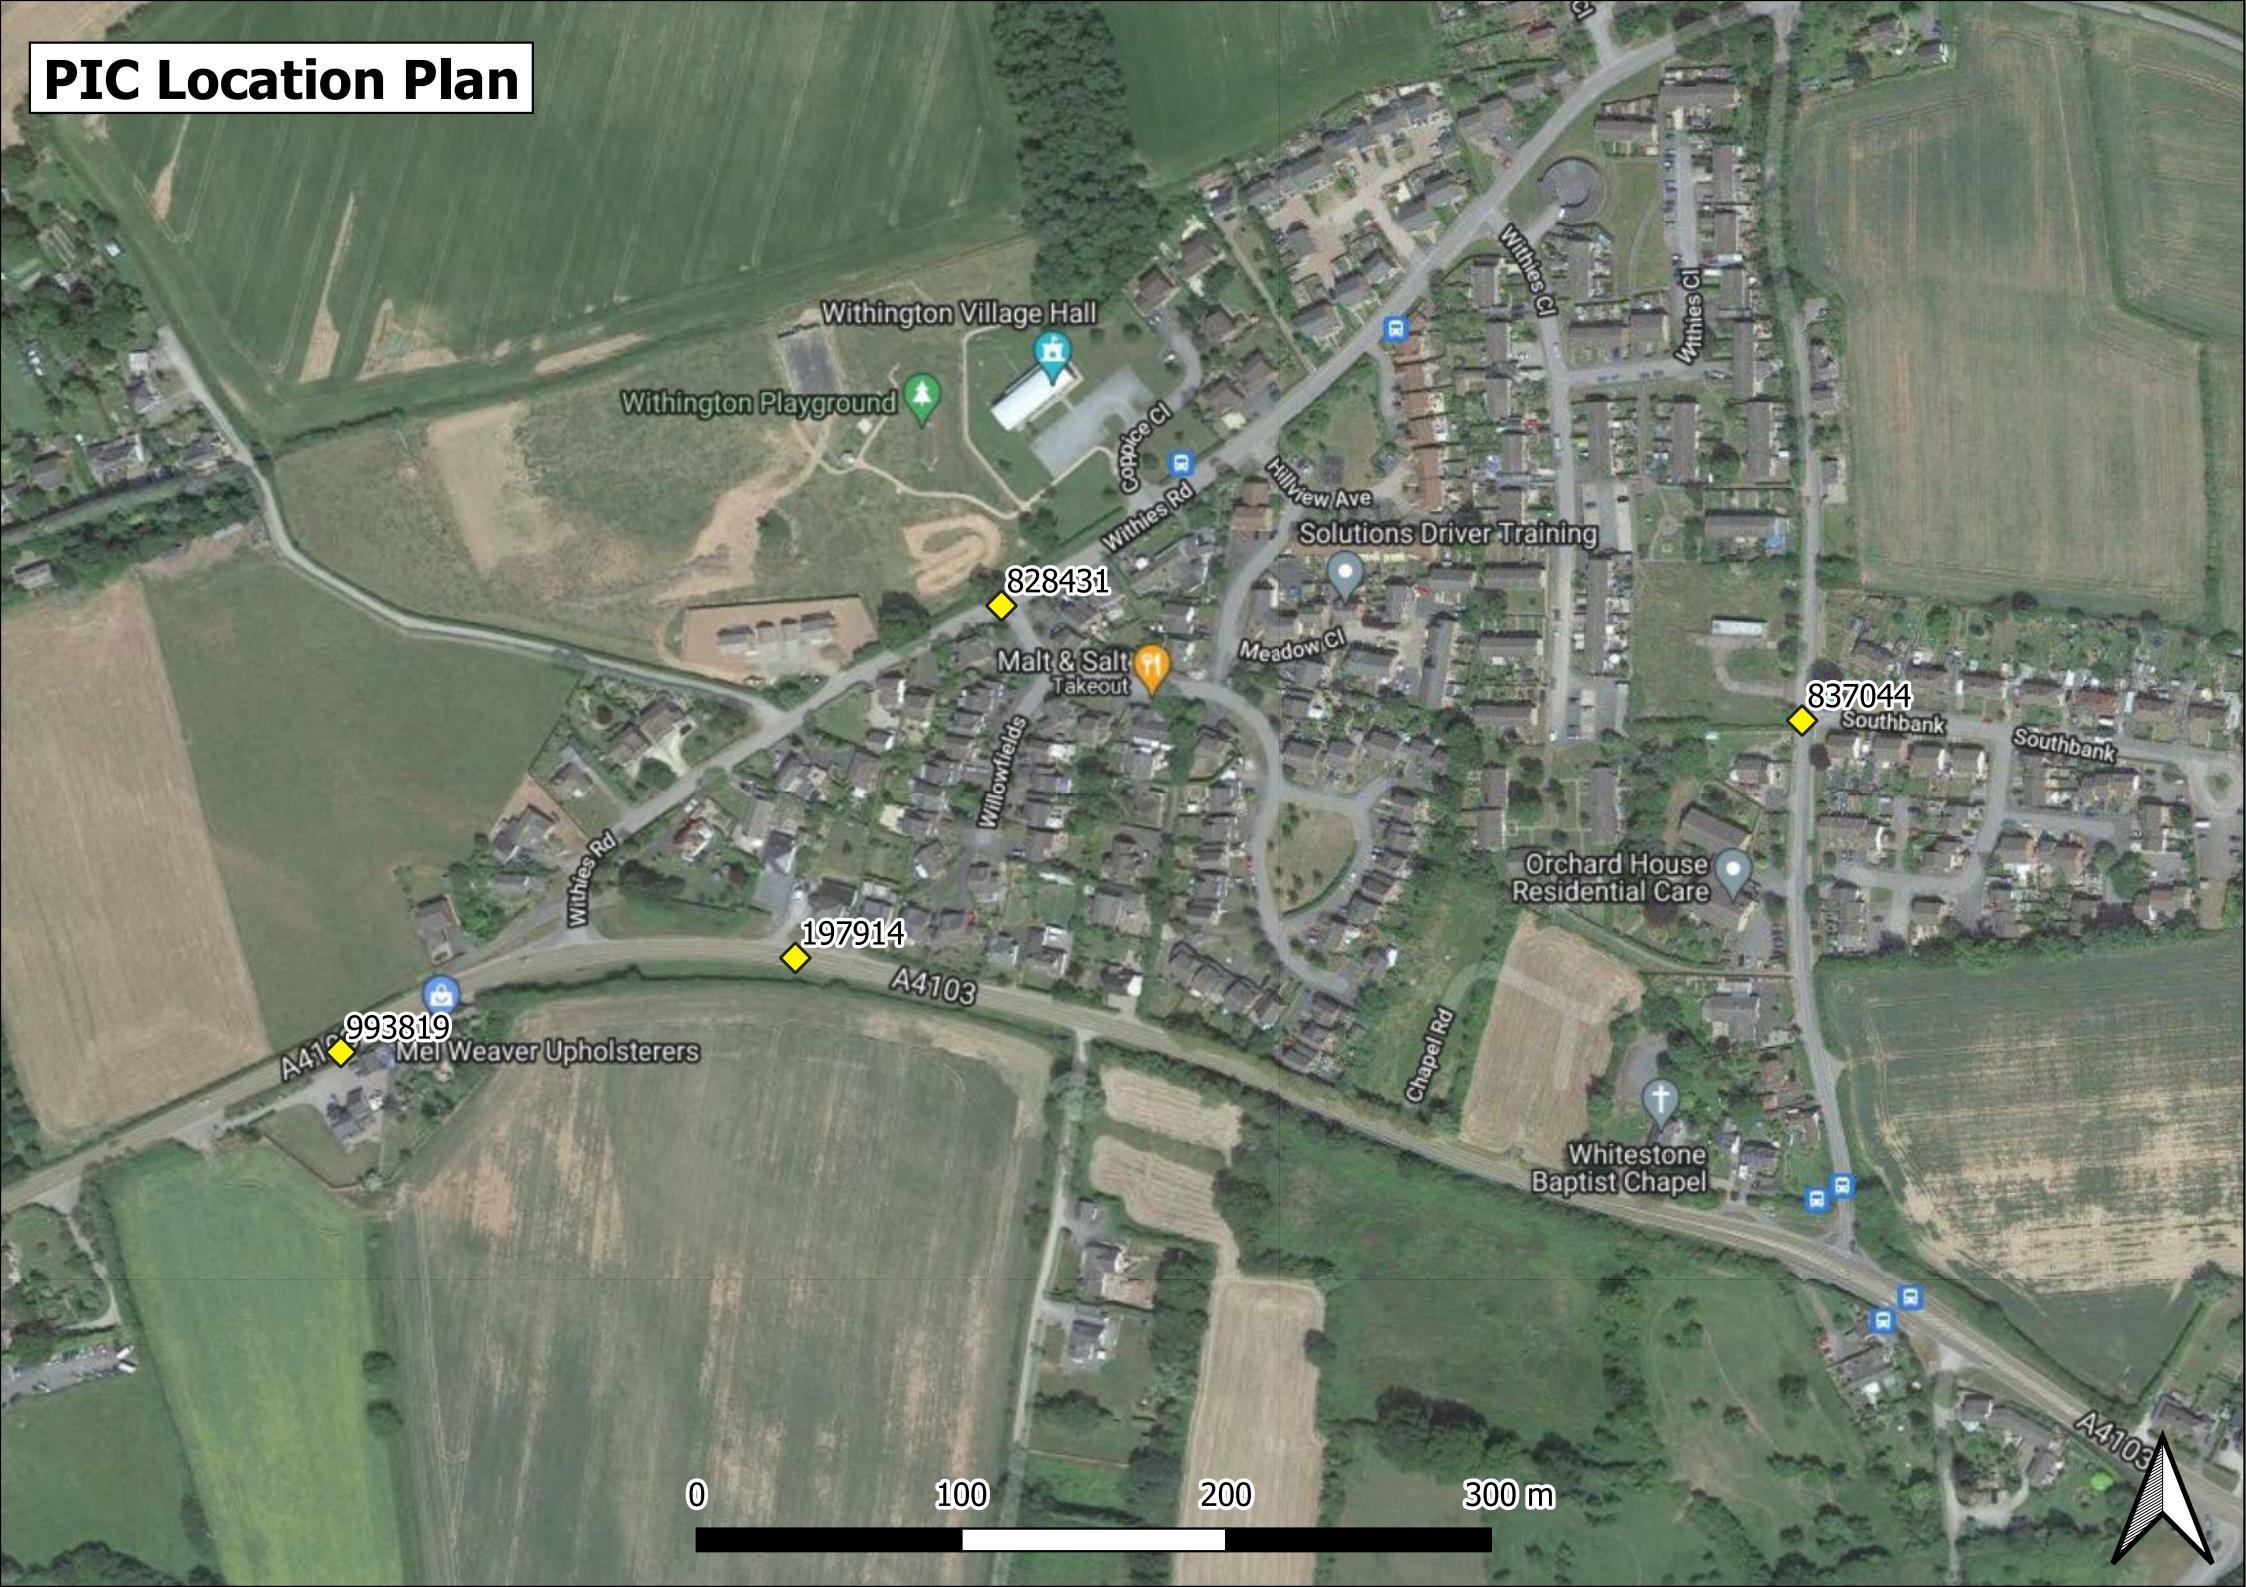
PIC Data

- 2.6 Personal Injury Collision (PIC) data has been obtained from HC for the most recent five year period available, until 24th June 2021, within Withington, off the A4103, as well as the C1130, C1131 and A465 (in the vicinity of the junction with the C1130). This area has been assessed as it will be utilised by vehicles routing towards the application site for construction and servicing purposes.
- 2.7 The review indicated that a total of four PICs had occurred within the study area, during the assessment period, in and around the built up area of Withington, all of which were recorded as 'slight' in severity. Appendix C contains the full PIC report and a plan demonstrating the locations of each incident.

Contributory Factors Report Summary - CotswoldTP - HR1 3RR Withington area data request

- 2.13 Based on the PIC data collected from HC, there is no apparent clustering of incidents over the most recent five-year period. Furthermore, the causation attributed to each recorded PIC indicates driver or pedestrian error, as opposed to an inherent highway safety concern. It is therefore concluded that the development of the application site will not result in a proliferation of PICs on the local highway network.

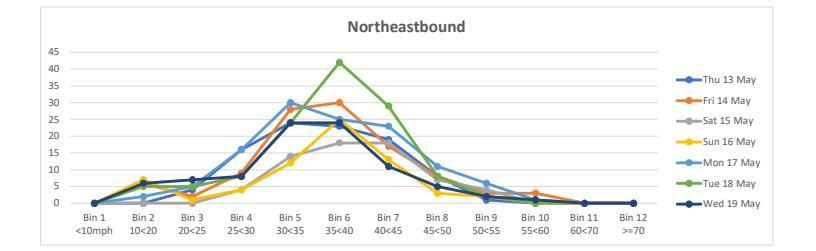
Direction: Northeastbound

| | Total | 85th | Mean | Standard | Bin 1 | Bin 2 | Bin 3 | Bin 4 | Bin 5 | Bin 6 | Bin 7 | Bin 8 | Bin 9 | Bin 10 | Bin 11 | Bin 12 |
|---|---|---|---|---|---|---|---|---|---|---|---|---|---|---|---|---|
| 7 Day Ave. | 95 | 44.5 | 36.3 | 7.9 | 0 | 4 | 3 | 9 | 22 | 27 | 19 | 7 | 3 | 1 | 0 | 0 |

- 2.16 As **Table 2.1** highlights, 20 two-way vehicle trips were recorded on the adjacent highway in the AM network peak (08:00 09:00), 17 two-way vehicle trips during the PM network peak (17:00 18:00) and 210 vehicle trips over a 24-hour period.
- 2.17 **Table 2.2** sets out the average and 85th percentile speeds recorded by the ATC.

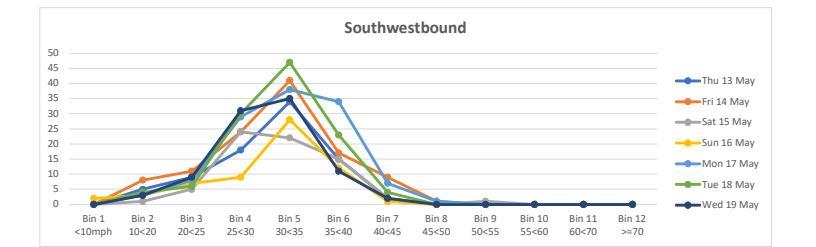
Direction: Southwestbound

| | Total | 85th | Mean | Standard | Bin 1 | Bin 2 | Bin 3 | Bin 4 | Bin 5 | Bin 6 | Bin 7 | Bin 8 | Bin 9 | Bin 10 | Bin 11 | Bin 12 |
|---|---|---|---|---|---|---|---|---|---|---|---|---|---|---|---|---|
| 7 Day Ave. | 93 | 37.3 | 31.0 | 6.1 | 0 | 4 | 8 | 24 | 35 | 18 | 4 | 0 | 0 | 0 | 0 | 0 |

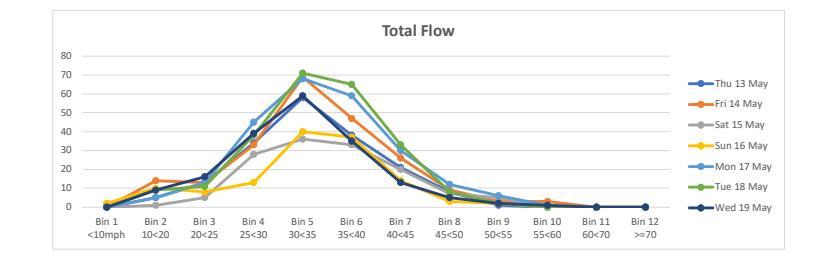
Direction: Total Flow

| | Total | 85th | Mean | Standard | Bin 1 | Bin 2 | Bin 3 | Bin 4 | Bin 5 | Bin 6 | Bin 7 | Bin 8 | Bin 9 | Bin 10 | Bin 11 | Bin 12 |
|---|---|---|---|---|---|---|---|---|---|---|---|---|---|---|---|---|
| 7 Day Ave. | 188 | 41.5 | 33.6 | 7.6 | 0 | 8 | 11 | 33 | 57 | 45 | 22 | 7 | 3 | 1 | 0 | 0 |

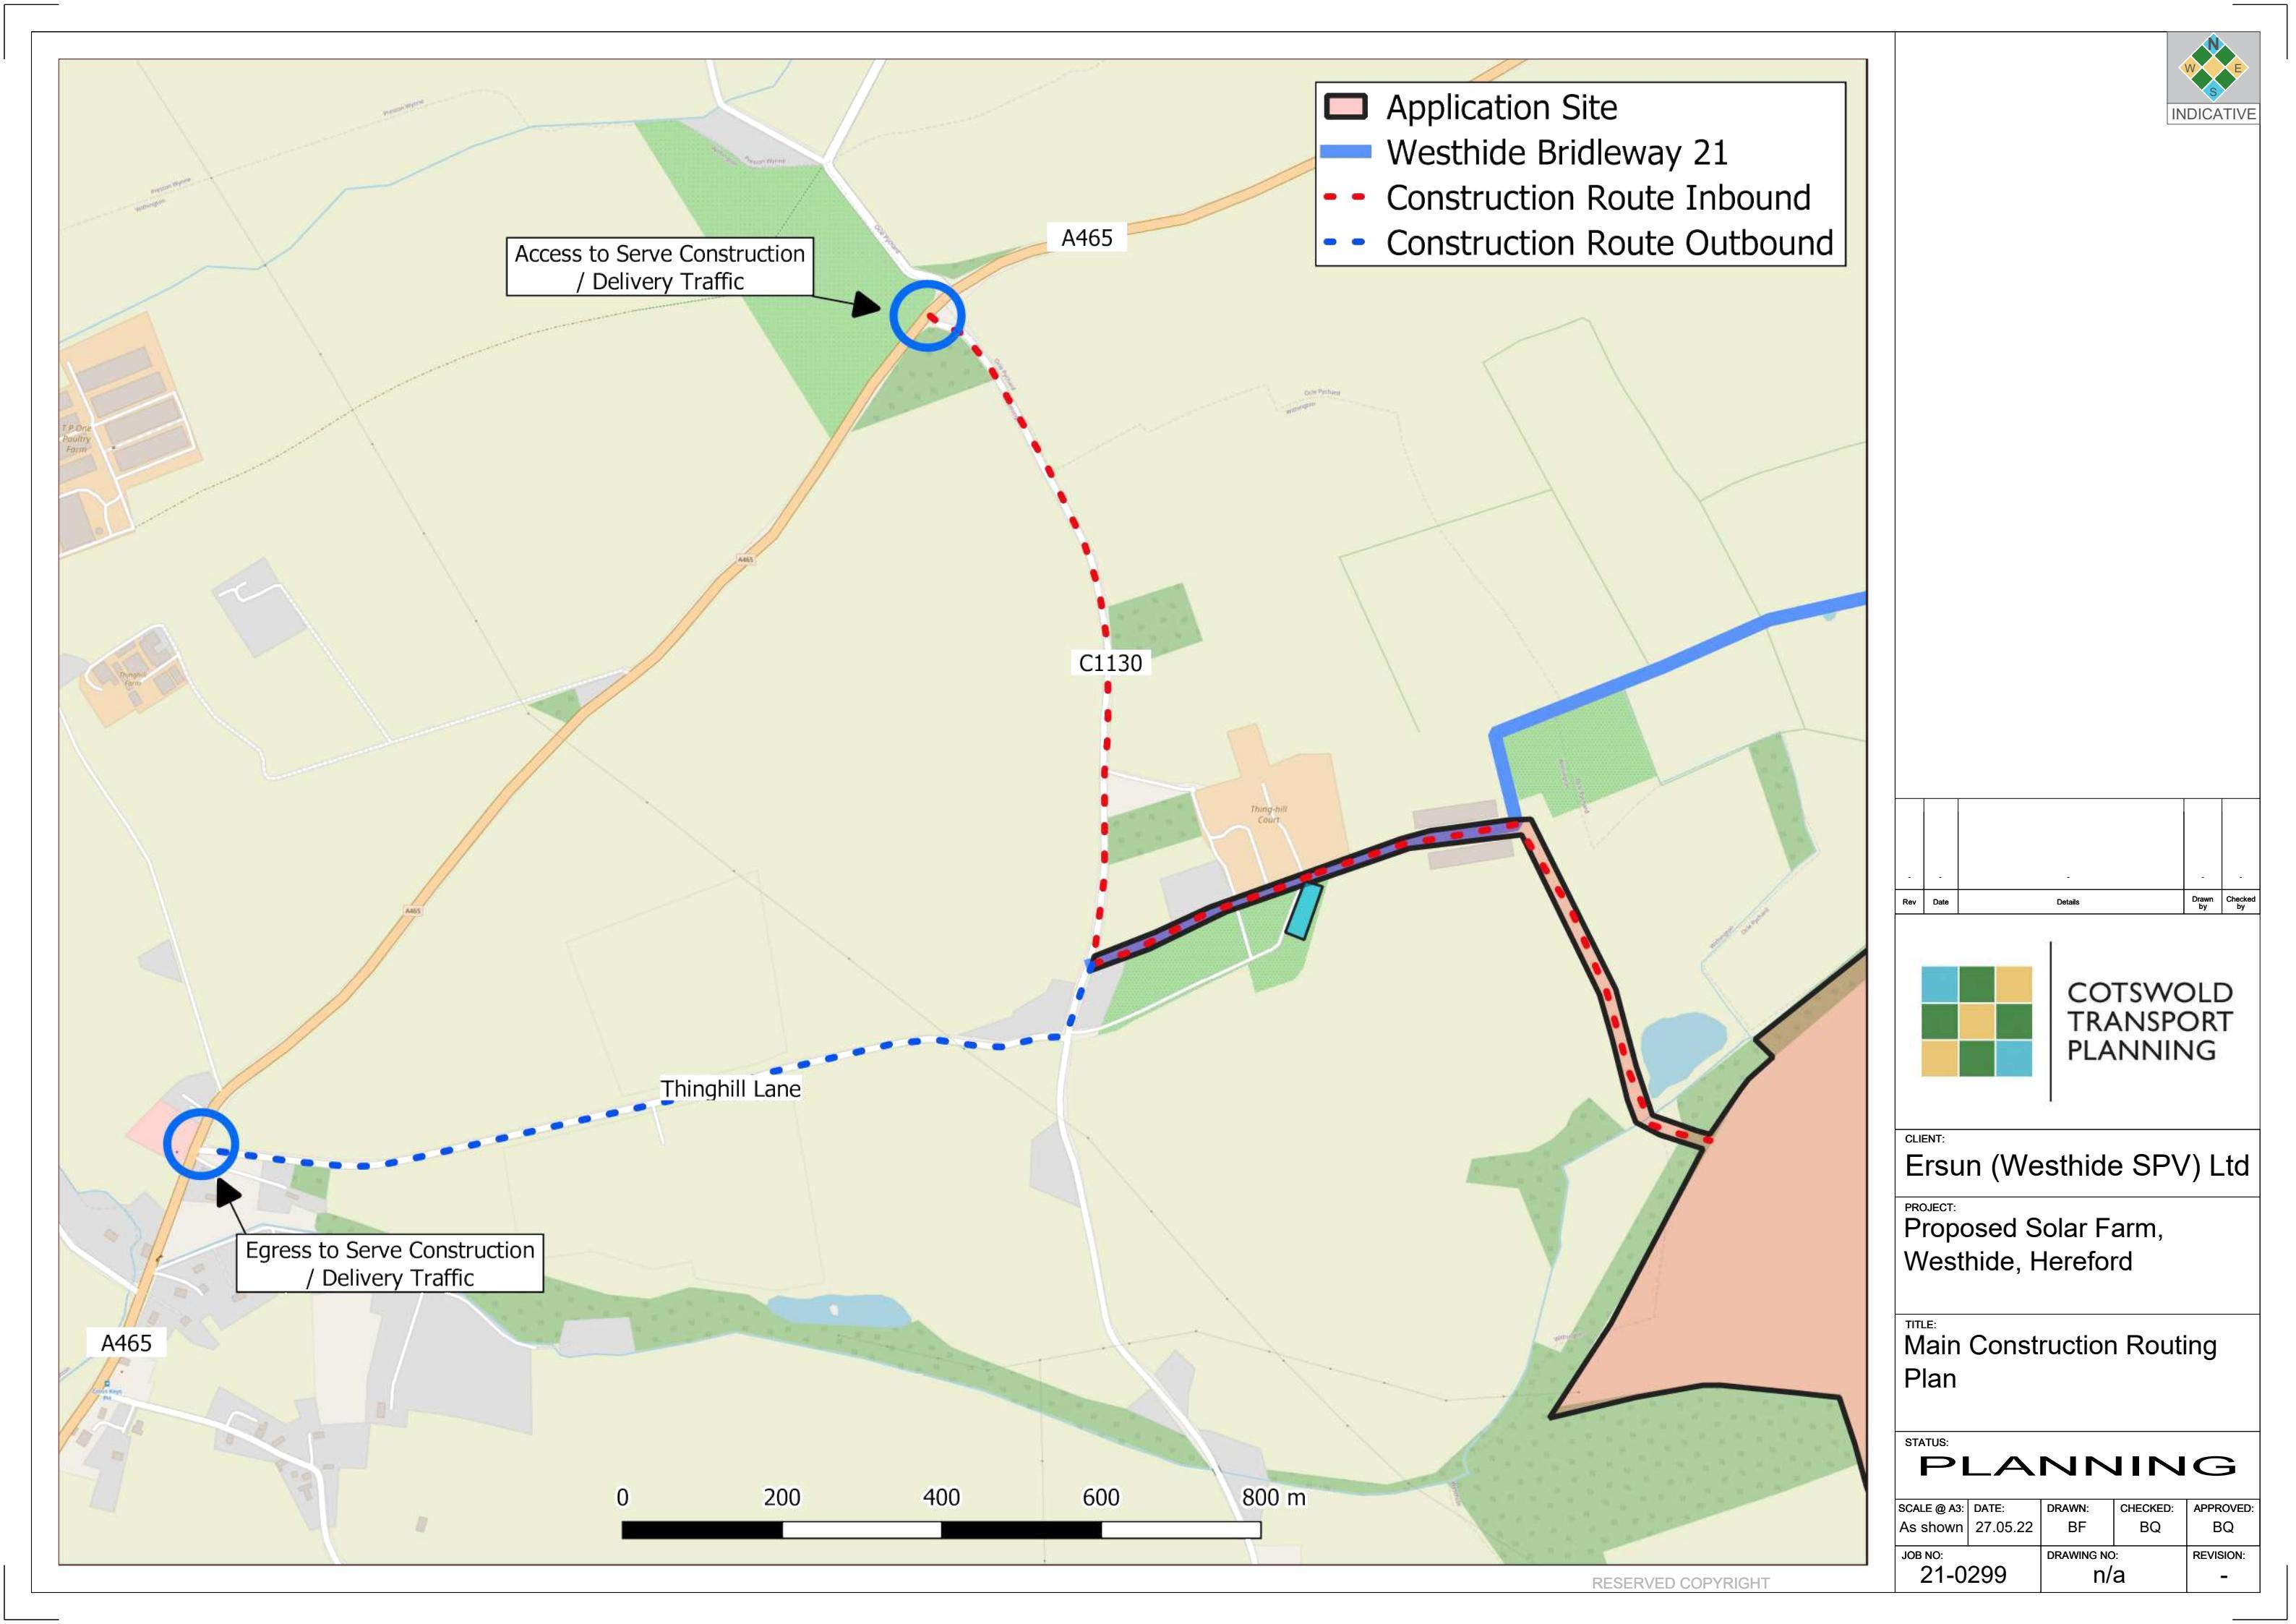
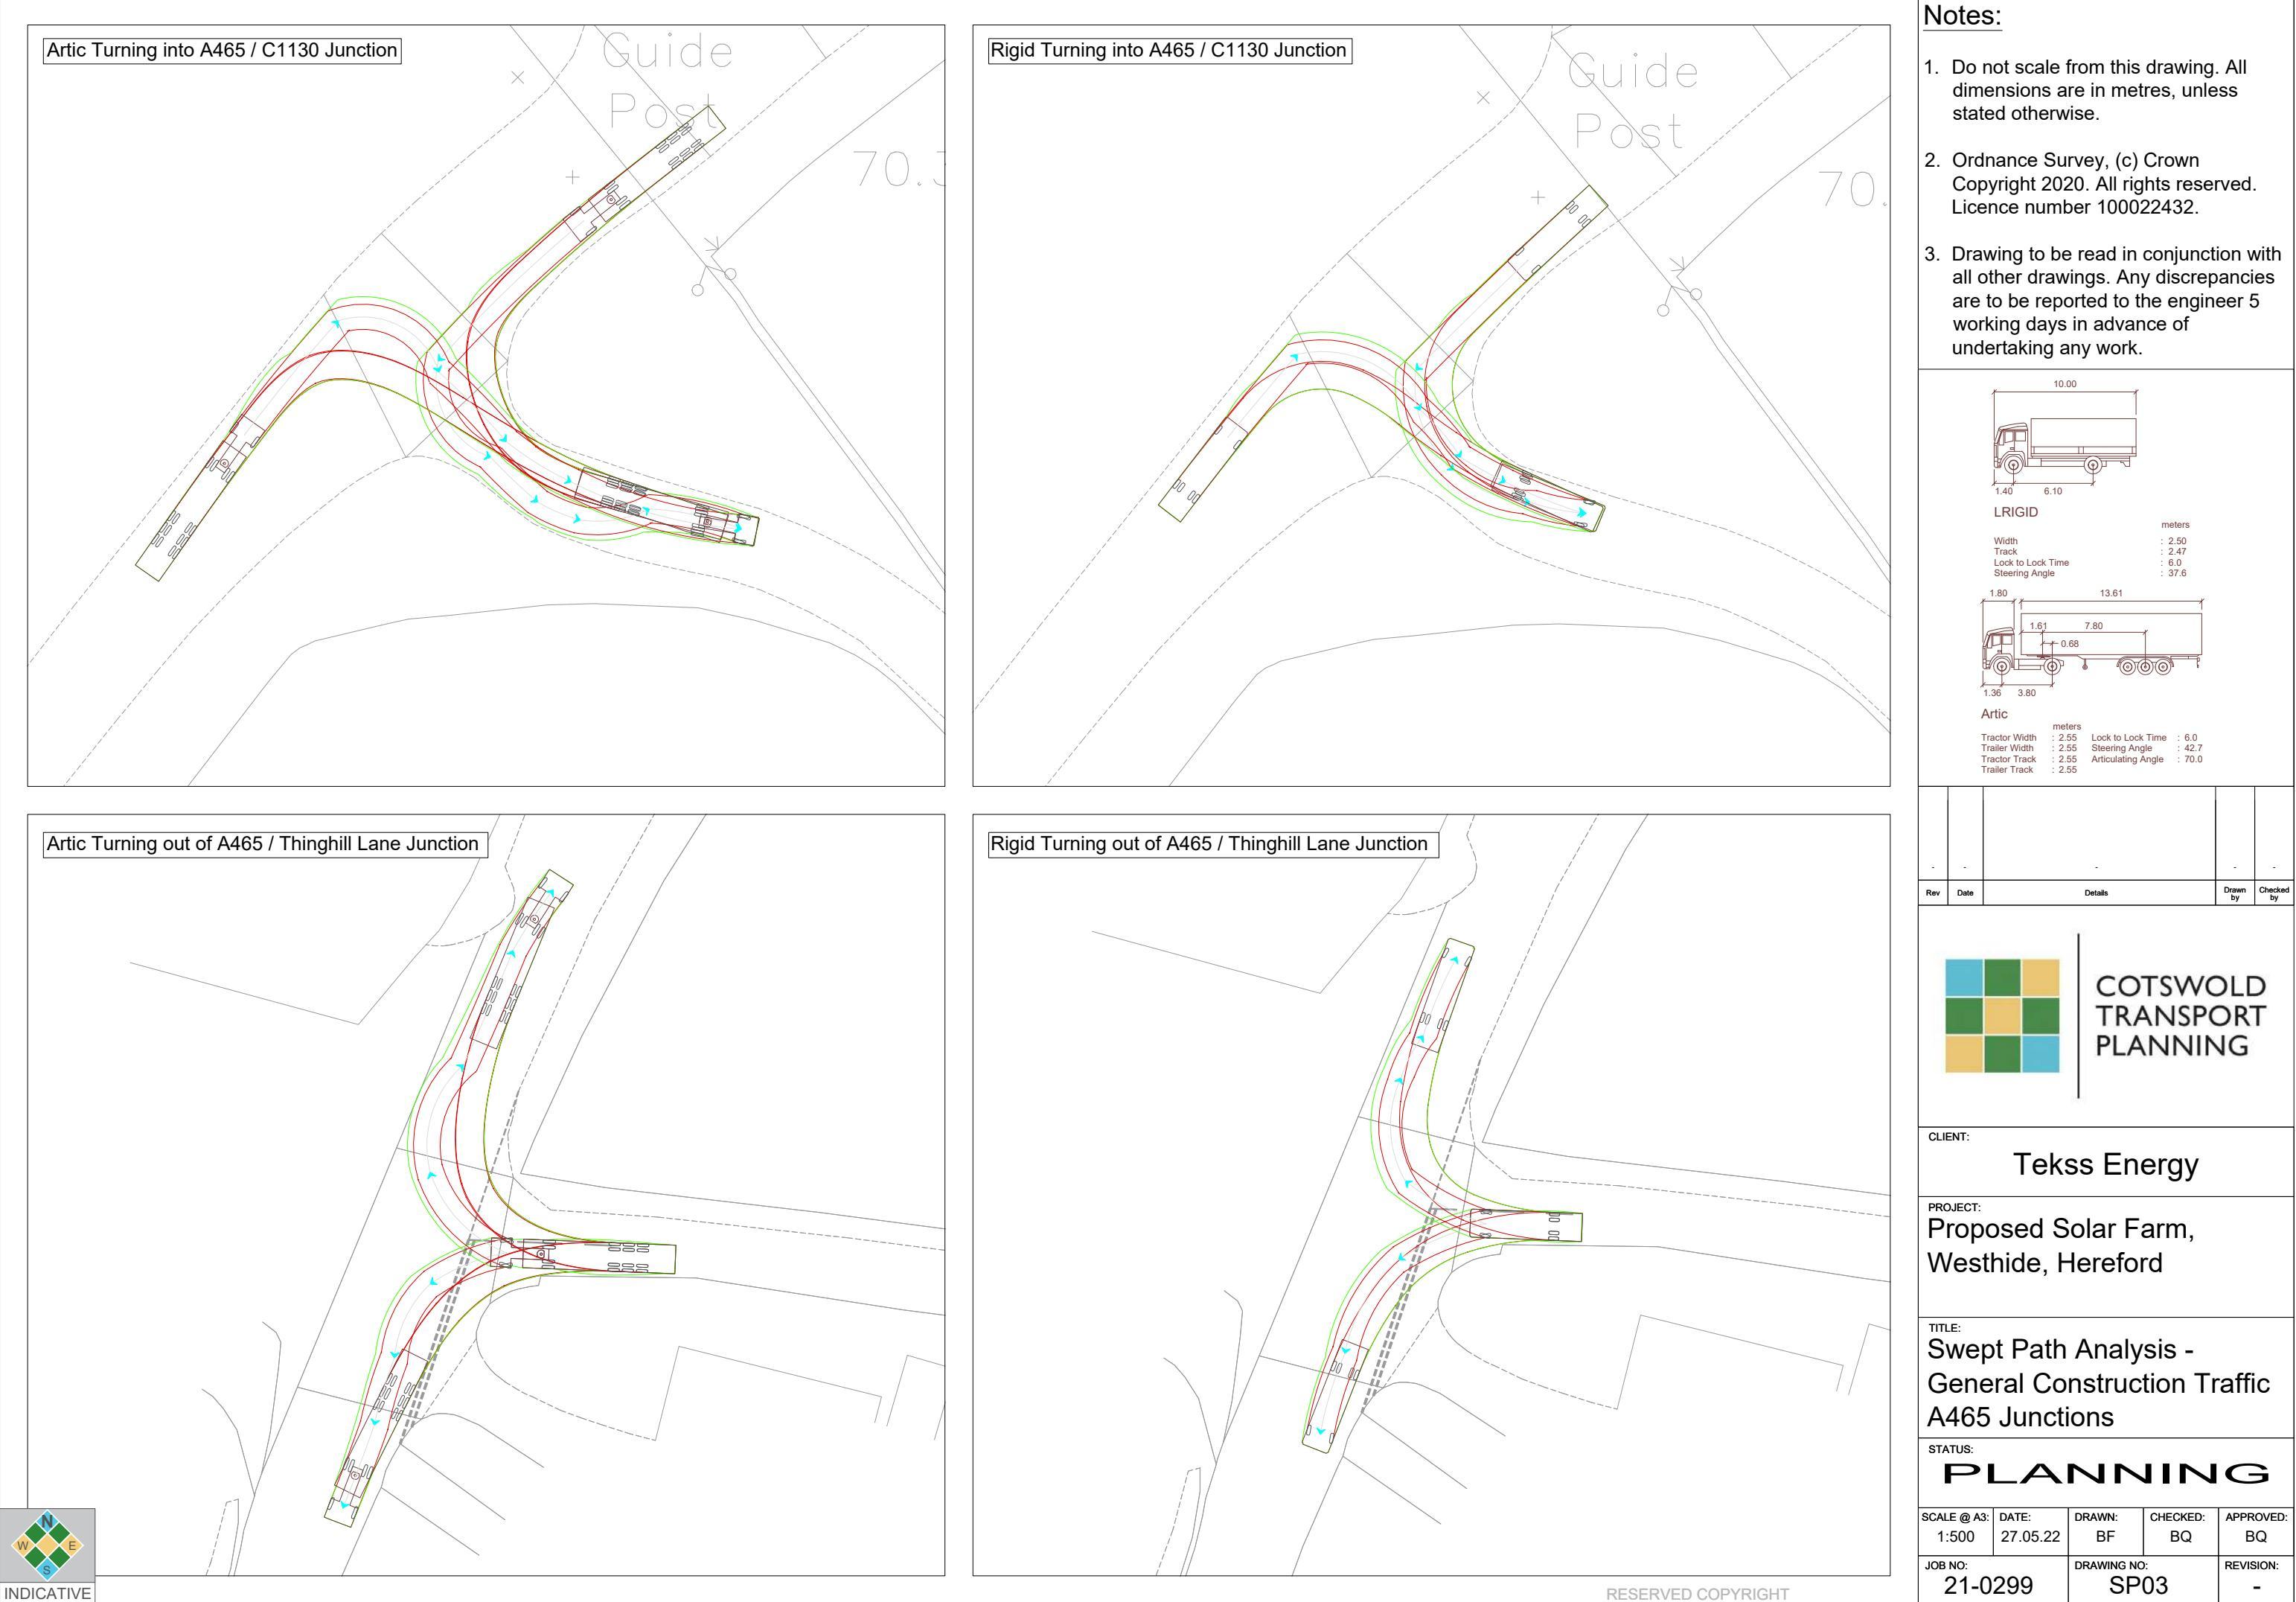
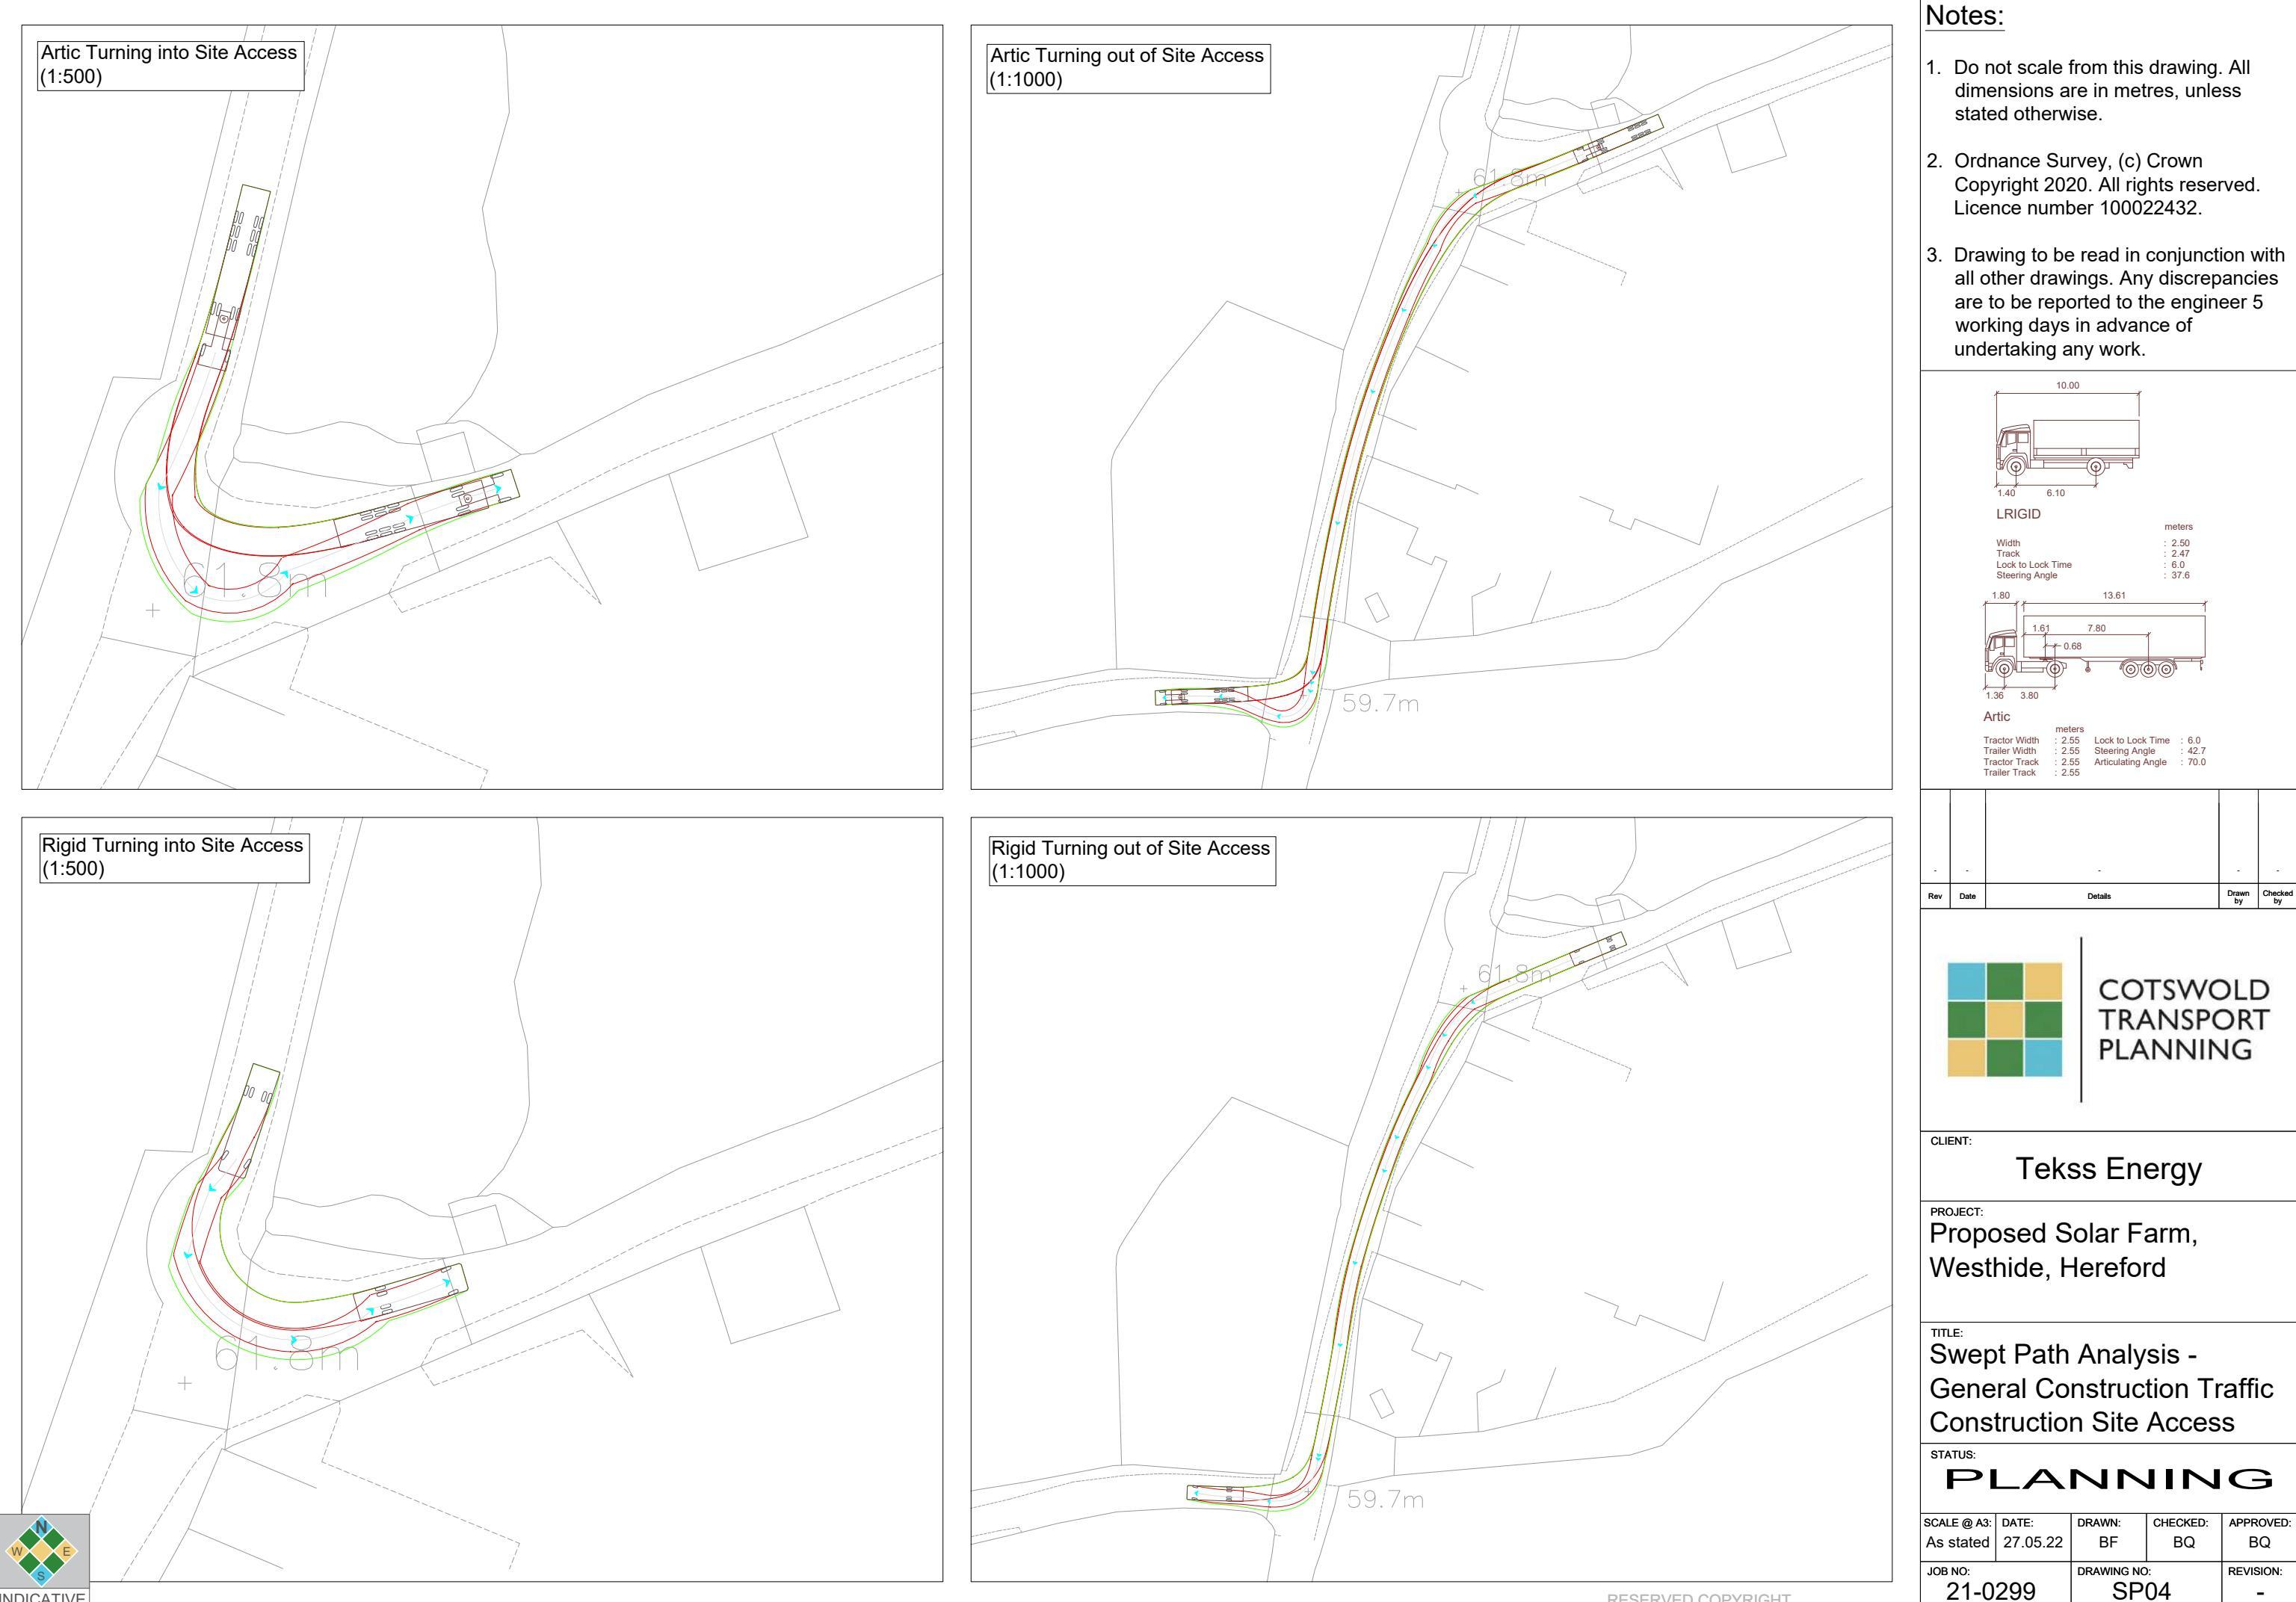
Construction Routing Plans

- 3.1 Following discussions with the Local Highway Authority, a revised access strategy for construction traffic has been presented in this section.
- 3.2 The majority of construction vehicles will travel to the site via the A465 to the north and west of the site, respectively, where materials will be stored and then transported via smaller vehicles to the application site, and this is detailed further in this section. Appendix E contains a plan demonstrating the routing option to the proposed main construction access point off the public highway for the site (to the north of the application site), as denoted in red dashed line.

- 3.3 The proposed construction access route will form a one-way routing arrangement, utilising the C1130 and Thinghill Lane. This arrangement has been agreed with HC during consultation discussions.

- 3.4 A swept path analysis of the largest expected vehicles to use this route to the site, including an articulated lorry and rigid truck, is also included in **Appendix E**, accessing via the northern A465 junction with the C1130 and egressing via the western A465 junction with Thinghill Lane.
