Ersun (Westhide SPV) Ltd

Solar Farm at Westhide, Hereford

Construction Traffic Management Plan

May 2022

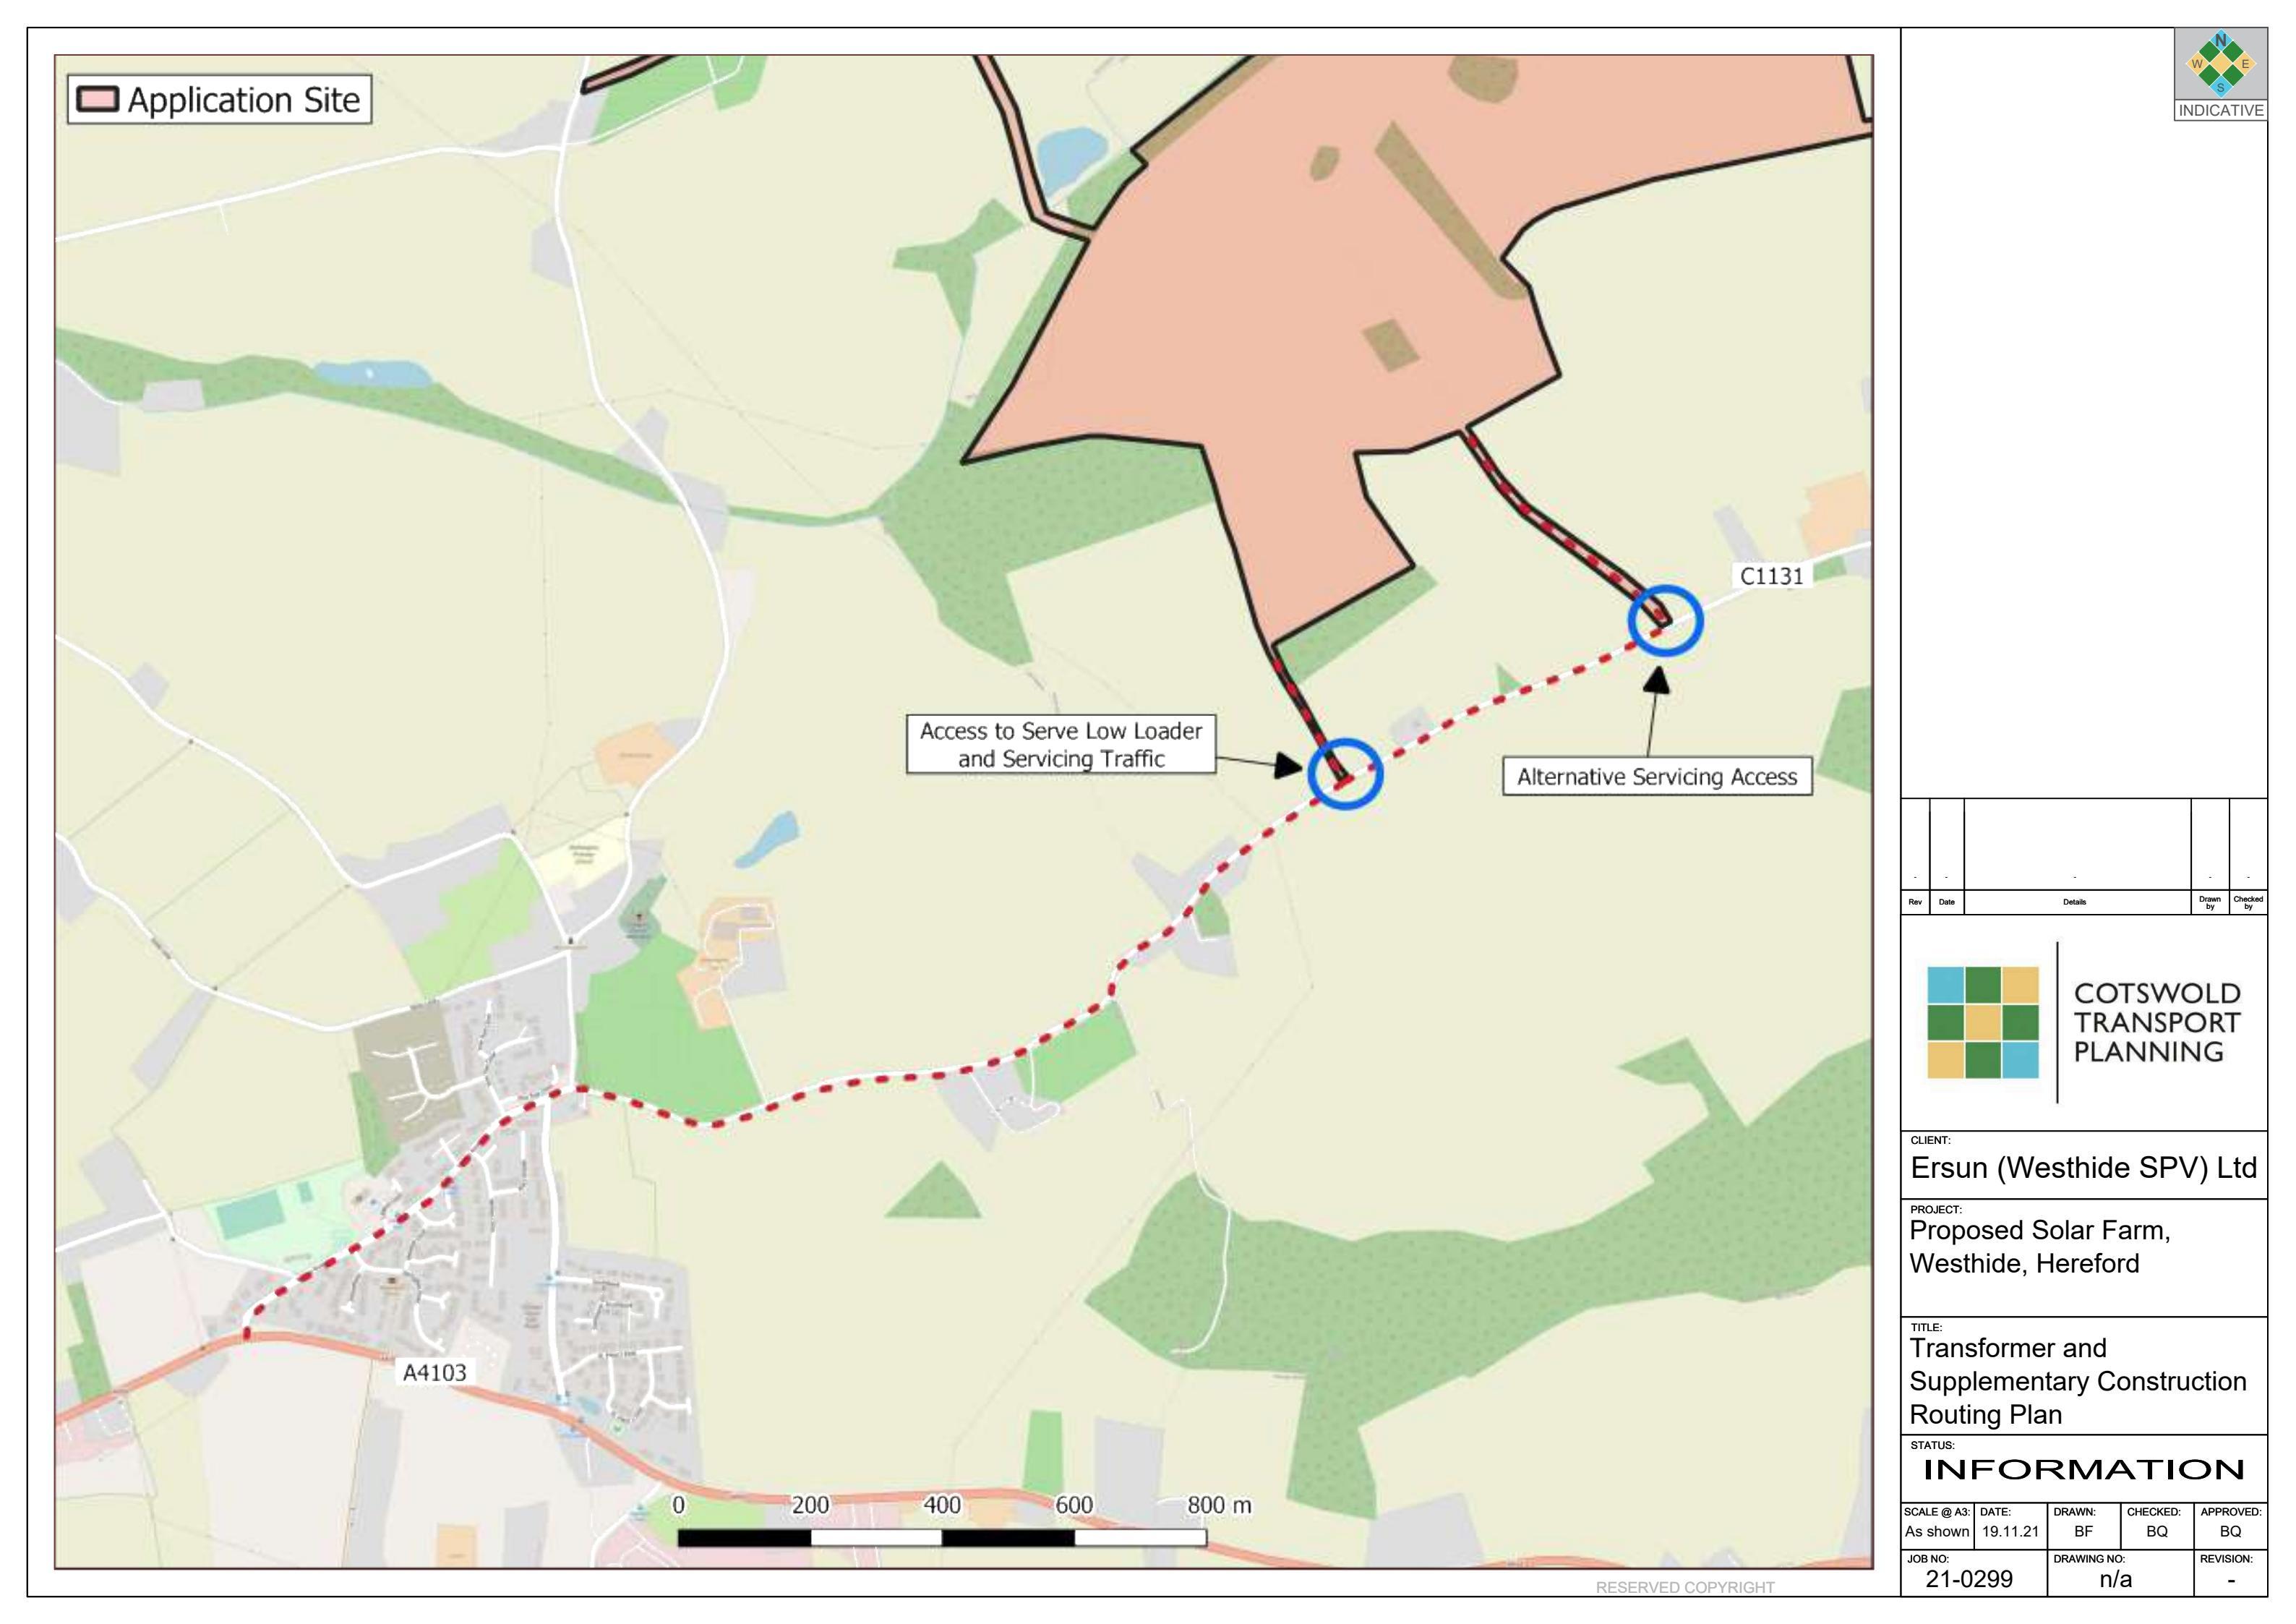
Transformer Routing Plans

- 3.5 The transformer will be delivered on an articulated low loader and due to the swept path of this vehicle, it cannot be transported along the main construction access track by a smaller vehicle. As such, the transformer will be delivered via the C1131, to the south of the site. Whilst the majority of construction vehicles will travel to / from site via the oneway routing arrangement, as above, it is envisaged that some construction vehicles will need to access the site from the south, alongside the transformer delivery.

- 3.6 A routing plan and swept path analysis drawing have been produced and provided at **Appendix F**, which demonstrates an articulated low loader vehicle accessing and egressing the site in a forward gear, from the A4103 to the south of the application site and along the C1131.

- 3.11 The swept path analysis indicates that a vehicle may require use of the adjacent verge to perform manoeuvres; to account for this, a condition survey is offered and further discussed in **Section 6**. Note, access to the site from the C1131 by a low loader will only involve two vehicle trips, to / from the site, during the construction period.
